Subject: **Update Programming Transmission Control Module (TCM) for Improved Upshifting (OE)**

Number: **05-16**

Model(s): **Touareg 3.2L V6 (eng. code BMX)**

Date: **Dec. 20, 2005**

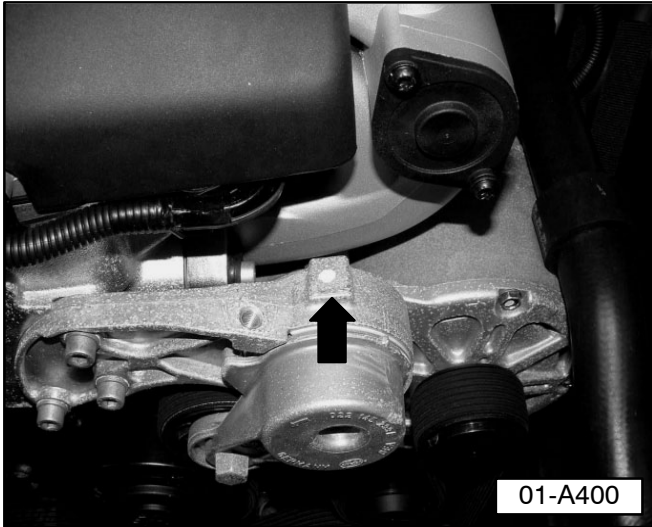
- ◀ – Raise hood, inspect for white dot located on accessory drive belt tensioner.
- If white dot is present, close out the Required Vehicle Update in O.T.I.S. Input appropriate code (see page 11).
- If white dot is not present, follow instructions to perform update programming (Flashing) of transmission control module.
