Technical Bulletin

Self-Leveling Suspension, Error Message Displayed in Multi-Function Display

43 06 01 Sept. 22, 2006 2010605 Supersedes T.B. Group 43 number 04-01 dated May 11, 2004 due to updated information.

Model(s)	Year	Eng. Code	Trans. Code	VIN Range From	VIN Range To
Touareg	2004	All	All	All	All

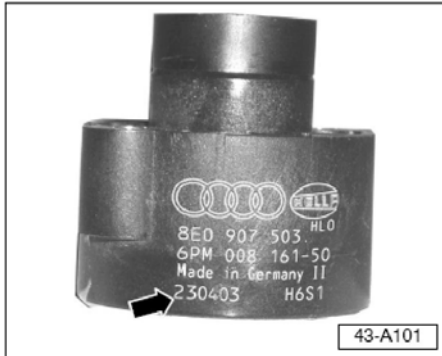
Identifying Sensors

Check manufacturing date -arrow- of all leveling sensors.

If leveling sensor manufacturing date is between February 01, 2003 and July 22, 2003 (ddmmyy):

If leveling sensor manufacturing date is not between February 01, 2003 and July 22, 2003:

- Replace leveling sensor, see Repair Manual Group 43, Self-Leveling Suspension.

- No service action required.
